HOUSATONIC RIVER BASIN  
STRATFORD, CONNECTICUT

BEAVER DAM LAKE DAM  
CT 00083

PHASE I INSPECTION REPORT  
NATIONAL DAM INSPECTION PROGRAM

MAY 1979

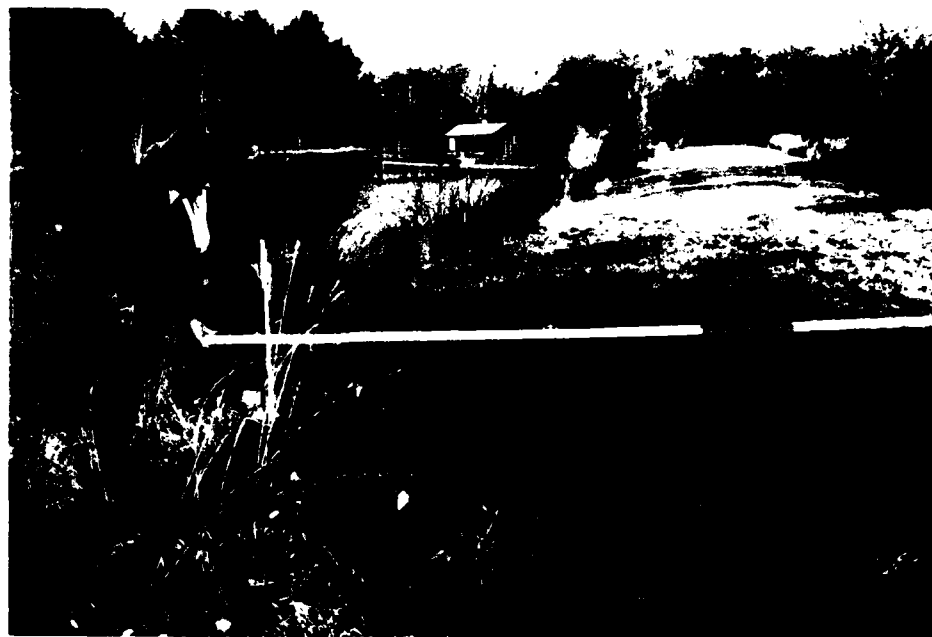
Visual examination indicates that the dam is in fair condition. Trespassing has led to the development of a path along the crest of the dam which could promote erosion of the embankment. There is an extensive growth of brush and trees on the downstream slope. Seepage may be present near the toe of the lower slope, but observations were obscured by the extensive undergrowth in this area. Displacement of the crest could be the result of movement of the embankment toward the reservoir.

PHOTO NO. 21 - About 600 feet right of spillway, evidence of past movement of crest toward reservoir, up to 12 inch of vertical displacement.

It is recommended that the owner should retain the services of a professional engineer to investigate the possibility of seepage along the toe of the lower downstream slope and to determine what type of seepage control measures are required, if any. In addition, the possibility of movement of the upstream slope should be investigated.
